Manhole Inspection Summary

Manhole # S29I__007MH

Insp Date: **9/8/08 9:48 AM**

Location Address: **725 - 700 Penn St**

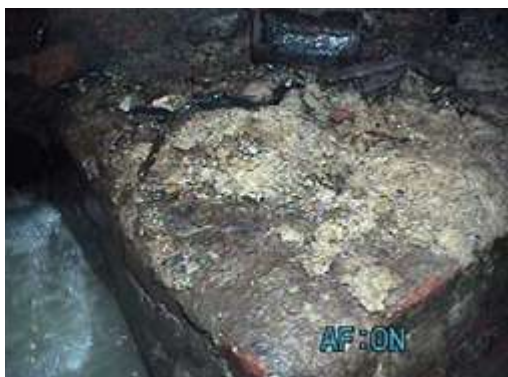
Miscellaneous

Sediment and debris on bench

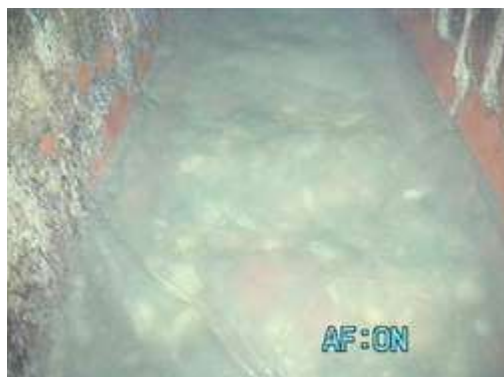
Miscellaneous

Debris in I3 channel

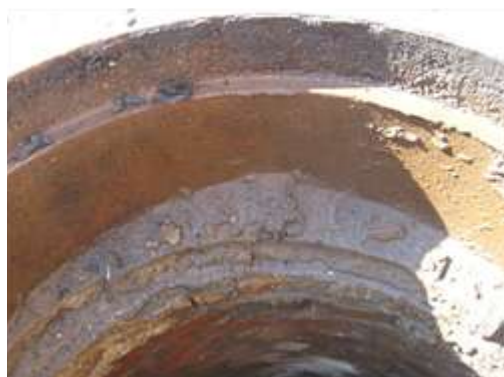
Defect 4

Offset: **3.** (in.)
75

Condition: ☐ Sound ☐ Cracked ☒ **Leaks**

Frame offset

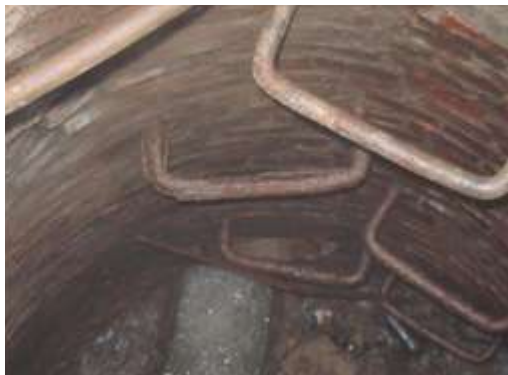
Defect 2

Count: **7** Missing: **0** ☒ **Corroded**

Corroded steps

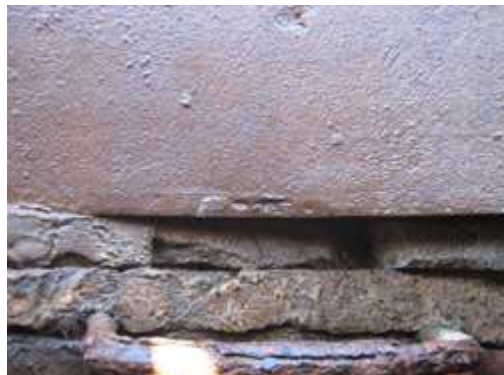
Defect 1

Condition: ☐ Sound ☐ Cracked ☐ Root Intrusion ☒ **Loose Brick** ☒ **Deteriorated**

Infiltration: ☐ None ☒ **Joint** ☐ Cracks ☐ Mortar ☐ Roots ☐ Wall

chimney has loose brick & is deteriorated with infiltration from joint

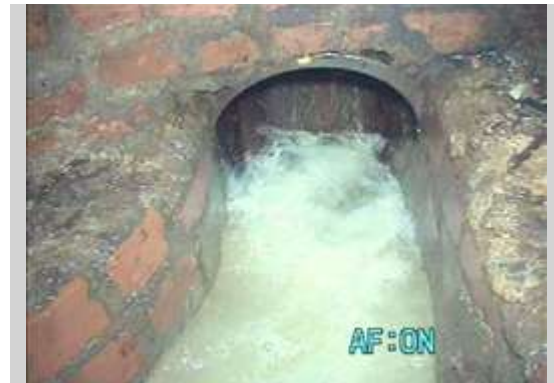
Drop In @ 3 O'Clock

Drop: **Inside** Rod and Bar
Angled: **Yes** Reading: **9.38** (ft.)
Inv Depth: **10.38** (ft.)
Drop Condition: **Open**
